1982 Diesel Vanagon Shift Linkage Bushing repair.

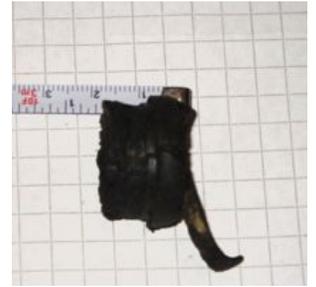
This bushing - from the Bentley manual - was 30 years old and provides a smooth place for the shift linkage rod to move through a frame mounted support tab. I tried pushing it back in place and adding some lubrication, but it failed after another year of service.

The problem is that it is located above the fuel tank and really hard to get to.

My solution was to find a substitute that would fit around the shift linkage rod and not require the removal of the fuel tank or the dis-assembly of the linkage.
